MANDATORY SERVICE BULLETIN

MSB18-08B

SUBJECT: Inspection and Maintenance Modification of Cylinder Assemblies

PURPOSE: To inspect and remove casting material build-up on the radius edge of identified cross-flow cylinder heads.

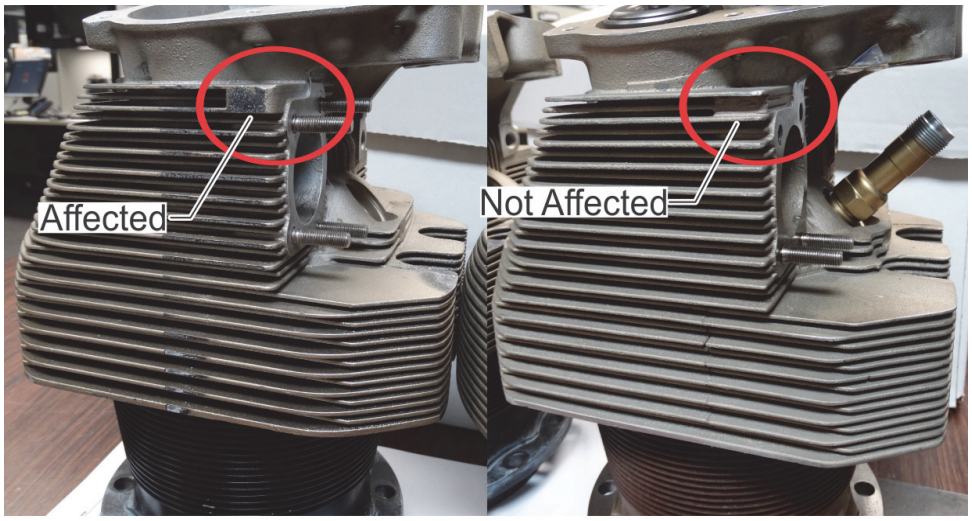
Figure 1. Affected Cross Flow Cylinders, Top Fin Flange typical

Several field reports indicate the potential for fracture initiation on engines (exceeding 500 hours of operation) at the radius edge of identified cylinder heads produced on or after 01 NOV 2014 (see Figure 2). The affected cylinder casting can be identified by the "filled" top fin flange area above the exhaust port as shown in Figure 1.

This service document is issued to provide inspection criteria and perform corrective action on affected cylinder assemblies. Affected cylinder head castings have a distinguishing feature (see Figure 1) from unaffected. Affected new and rebuilt engines with serial number 1036883 and later were inspected and corrected at the factory to comply with this Service Document. Additionally, all cylinder heads stamped with the letter **"S"** (regardless of serial number) meet full compliance and do not require additional inspection, see Figure 3.

Identified Cylinder Assemblies, Replaced After 01 Nov 2014

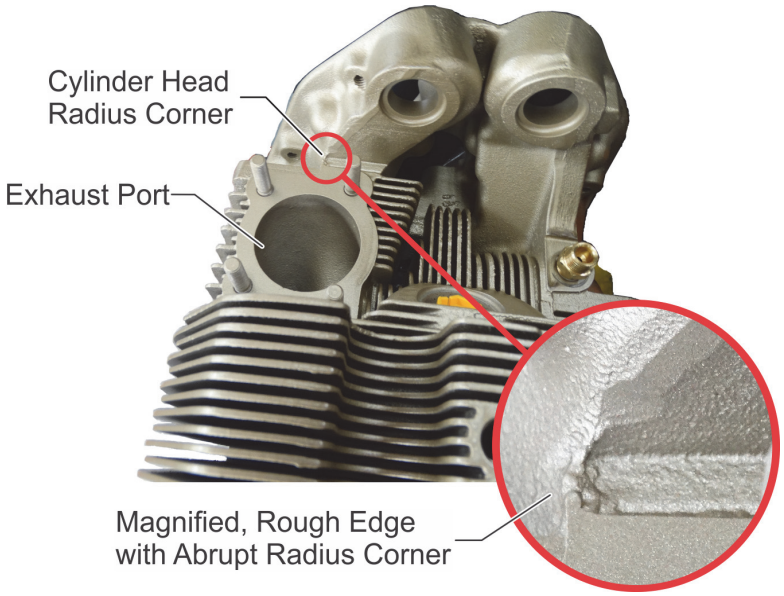
Figure 2. Abrupt Radius Edge with Flash Material Build-up, typical

4. Begin removing built-up flash material using a pencil grinder or 1/4" round metal file held approximately at a 30 degree angle (i.e. Nickolson Bastard Cut file, see Figure 7).

Carefully, vary your filing motion until a smooth, blended "tapered" radius edge is achieved at the radius corner. Remove ONLY enough material from the cylinder head to achieve dimensional specification, see Figure 4. The finished radius blend should not exceed 0.20" depth of the material removed.

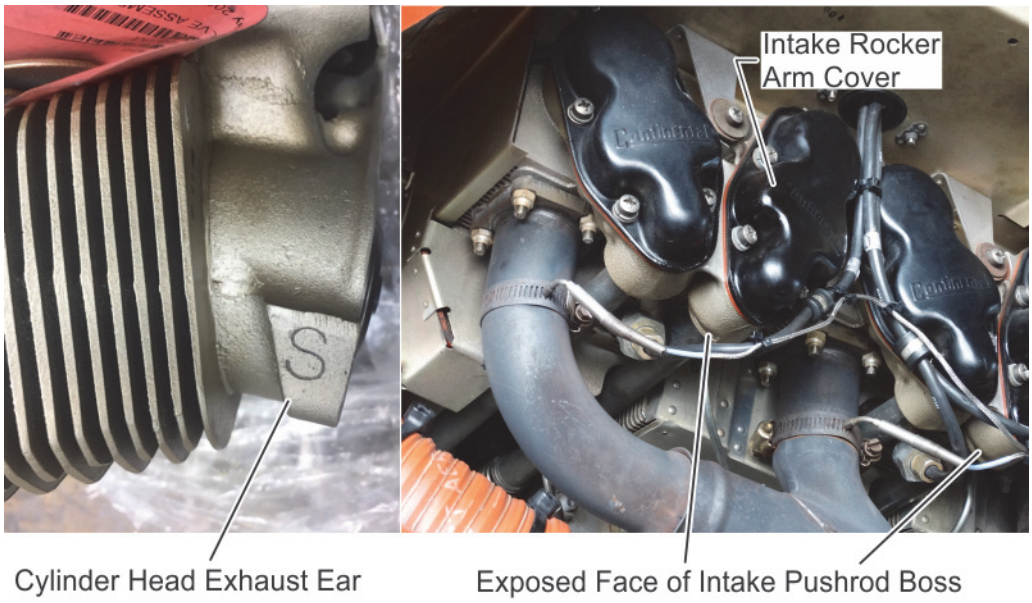
NOTE: Refer to the engine log book for documentation of prior compliance; if prior compliance is recorded and the letter "S" has been metal stamped (1/4") on either the cylinder head exhaust ear or face of the intake pushrod boss, the cylinder assembly is in full compliance with this Service Document (MSB18-08B).

Figure 3. Cylinder Head Indicates Prior Compliance, Stamped with Letter “S”

6. Metal stamp the letter "S" (1/4" stamp) on the face of the intake pushrod boss (reference Figure 3) to indicate part compliance.
7. Use compressed air and a clean dry rag to remove residual material.

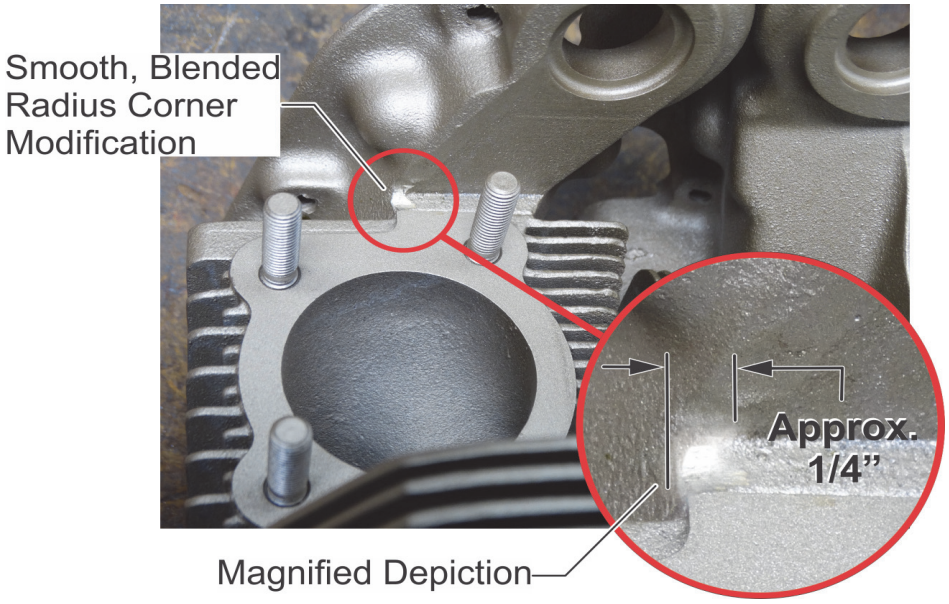
Figure 4. Smooth Radius Corner after Radius Blend Modification

5. Inspect the cylinder head surface and remove all nicks, burrs, sharp angles or edges using a de-burring tool and Scotch-Brite© (ultra fine or equivalent). Evenly shape, taper, and smooth all interfering surfaces where material was removed (see Figure 4).

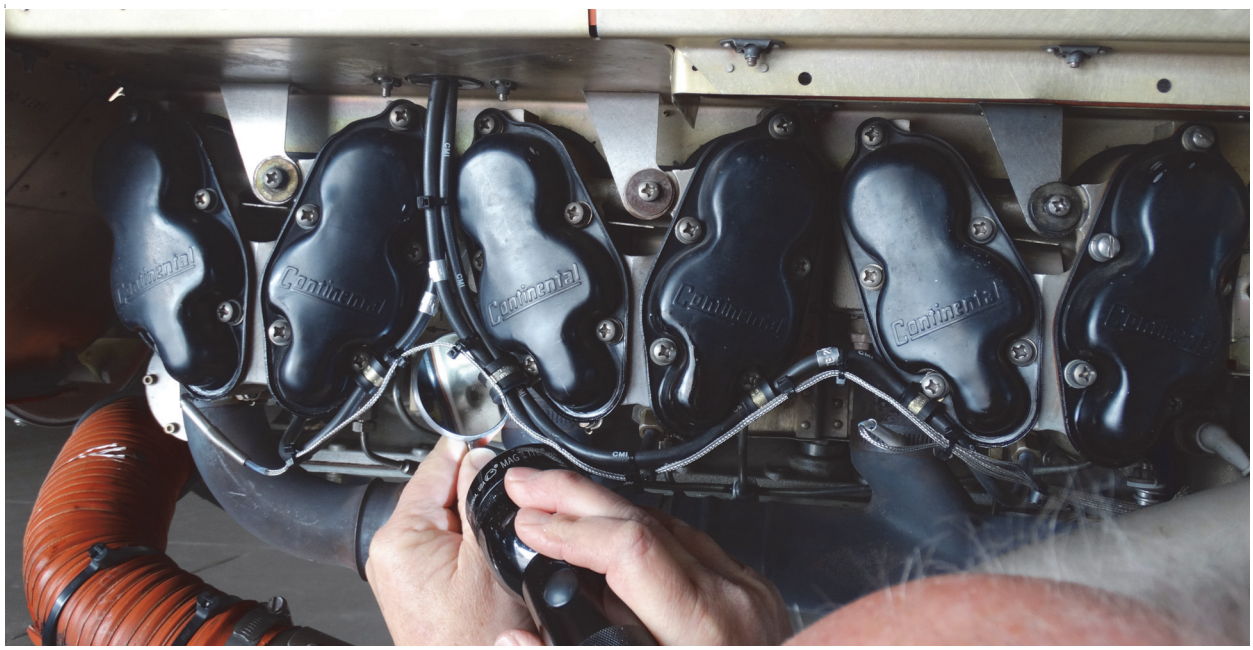
2. If the cylinder head exhaust ear is not stamped with the letter “S” or is obscured by baffling, inspect the radius corner angle below the exhaust port (see Figure 5) for any casting flash build-up or sharp radius edges. The radius corner should be tapered and blended smooth (reference Figure 4).

Figure 5. Cylinder Head Inspection Area, typical aircraft installation

3. Perform a "Non-Destructive Visual Inspection" according to the latest instructions in M-0, Standard Practice Maintenance Manual, Chapter 11, on the cylinder head radius corner (all possible angles). All cracks require attention, regardless of size or location. If a fissure, crack or physical damage is identified, replace the cylinder. Contact Continental Customer Service (Section V on page 6) to order replacement parts.

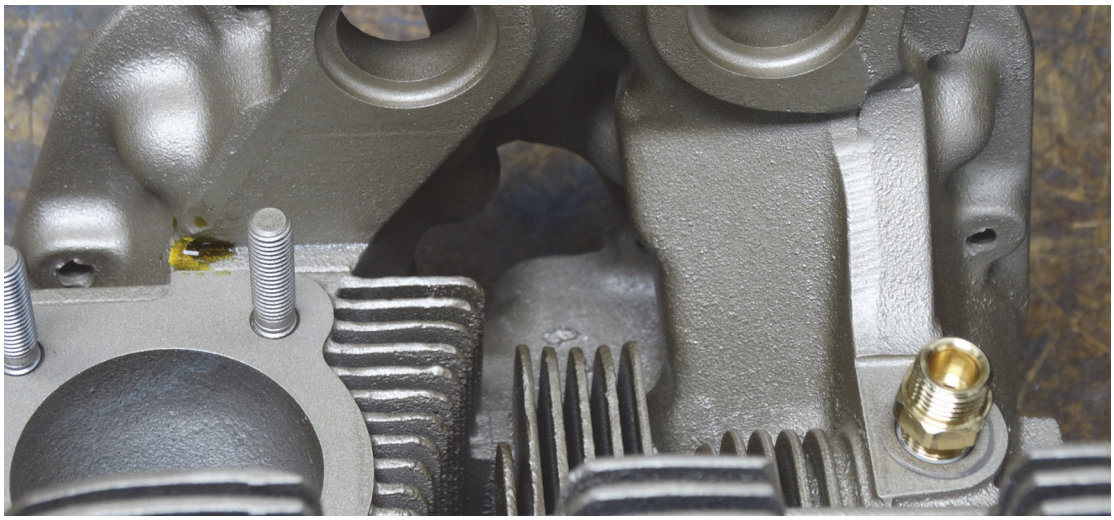
Figure 8. Cylinder Head, Alodine Application

8. Use an alodine touch up pen (Alodine® 1132™ Touch-N-Prep® Coating, Henkel Corporation) or equivalent (as specified by MIL-DTL-81706B, (PIN M817061A6D)) to apply alodine to machined areas or any other areas of exposed metal, as instructed by the engine's primary Instructions for Continued Airworthiness (ICA).
9. Create a logbook entry detailing the compliance action taken in accordance with this Service Document (MSB18-08B). The logbook entry must record all cylinder head serial numbers and include a complete listing of parts used in this installation.
10. If any equipment was removed to gain access, continue with engine assembly according to the primary Instructions for Continued Airworthiness (ICA).
