BOLLETTINO TECNICO

N° **139-085**

SUBJECT: Fire Extinguisher Bottle Assy P/N 3G2620V00131

HELICOPTERS AFFECTED: AB139/AW139 helicopters from S/N 31005 up to S/N 31067 (except S/N 31007) and S/N 31070, S/N 31071.

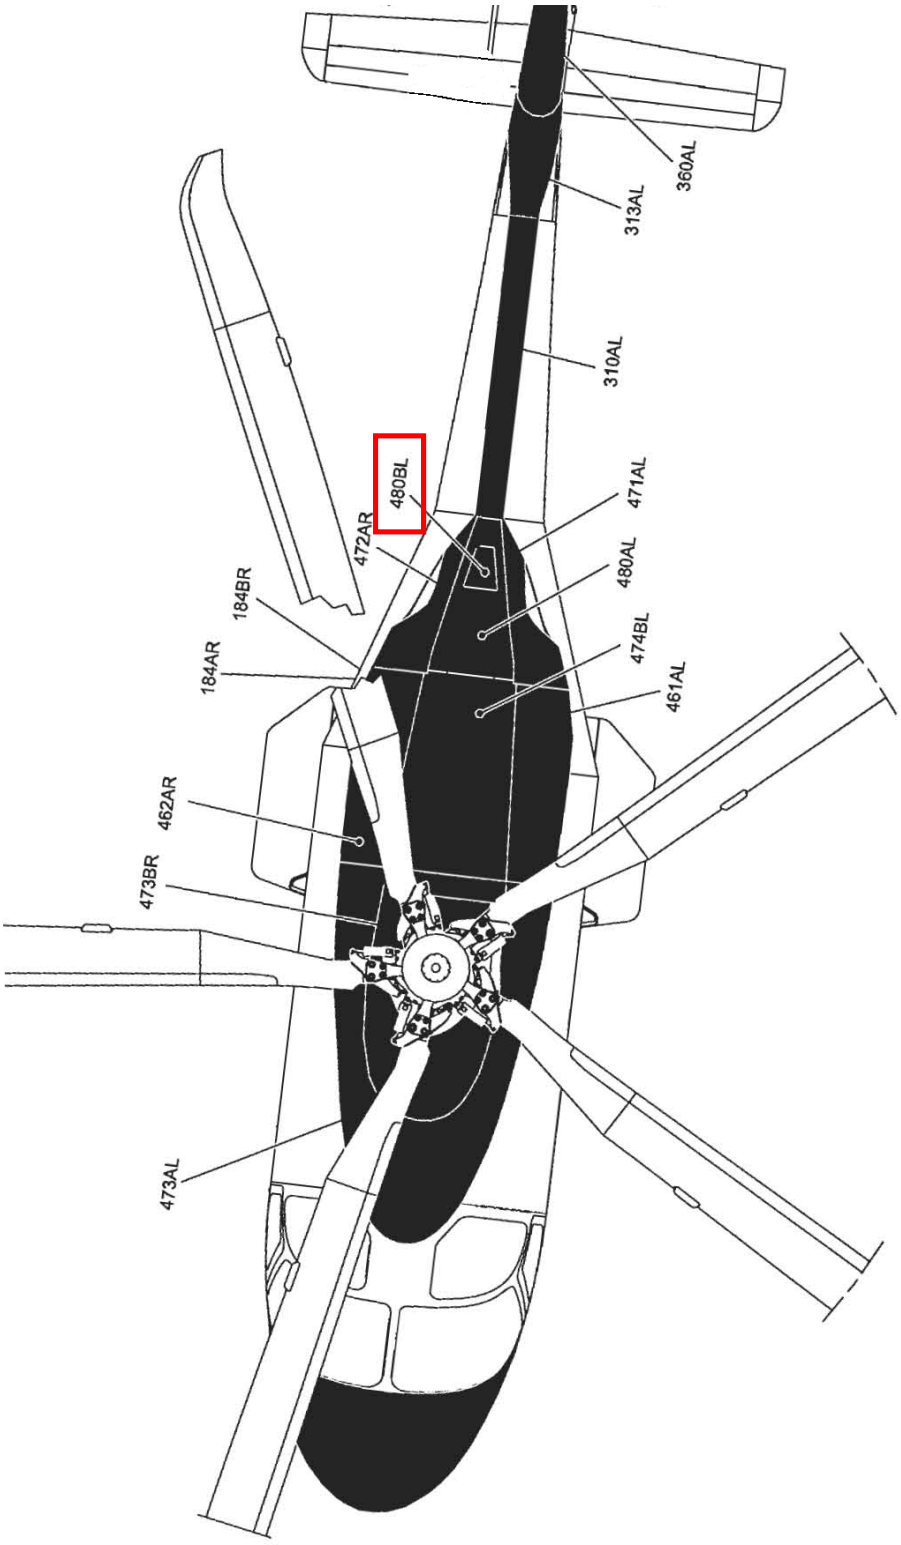
Figure 1

3. With reference to figure 1, open the access door 480BL. Refer to Aircraft Maintenance Publication (see data module n° 39-A-06-41-00-00A-010A-A).

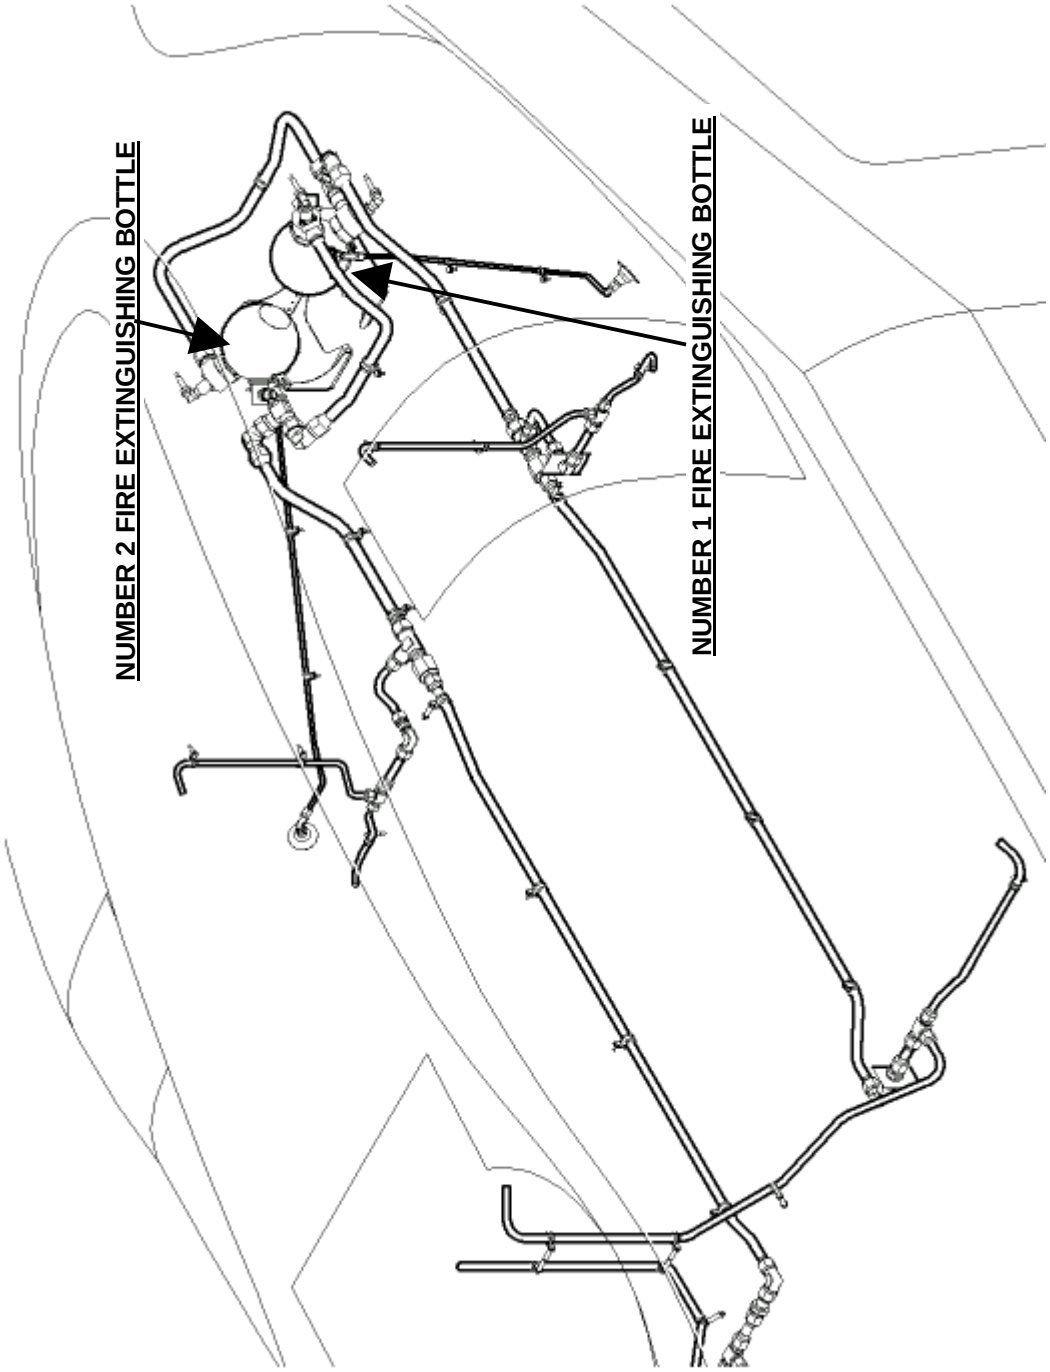
Figure 2

4. With reference to figure 2, gain access to the Number 1 fire extinguishing bottle.

8. With reference to figure 2, gain access to the Number 2 fire extinguishing bottle and repeat steps 5. thru 7.

6. If the receptacles are found to be inverted, replace the defective bottle with a bottle P/N 3G2620V00131 having the receptacles in the proper position. Refer to Aircraft Maintenance Publication (see data modules n° 39-A-26-21-01-00A-520A-A and n° 39-A-26-21-01-00A-720A-A for Number 1 fire extinguishing bottle and data modules n° 39-A-26-22-01-00A-520A-A and n° 39-A-26-22-01-00A-720A-A for Number 2 fire extinguishing bottle).

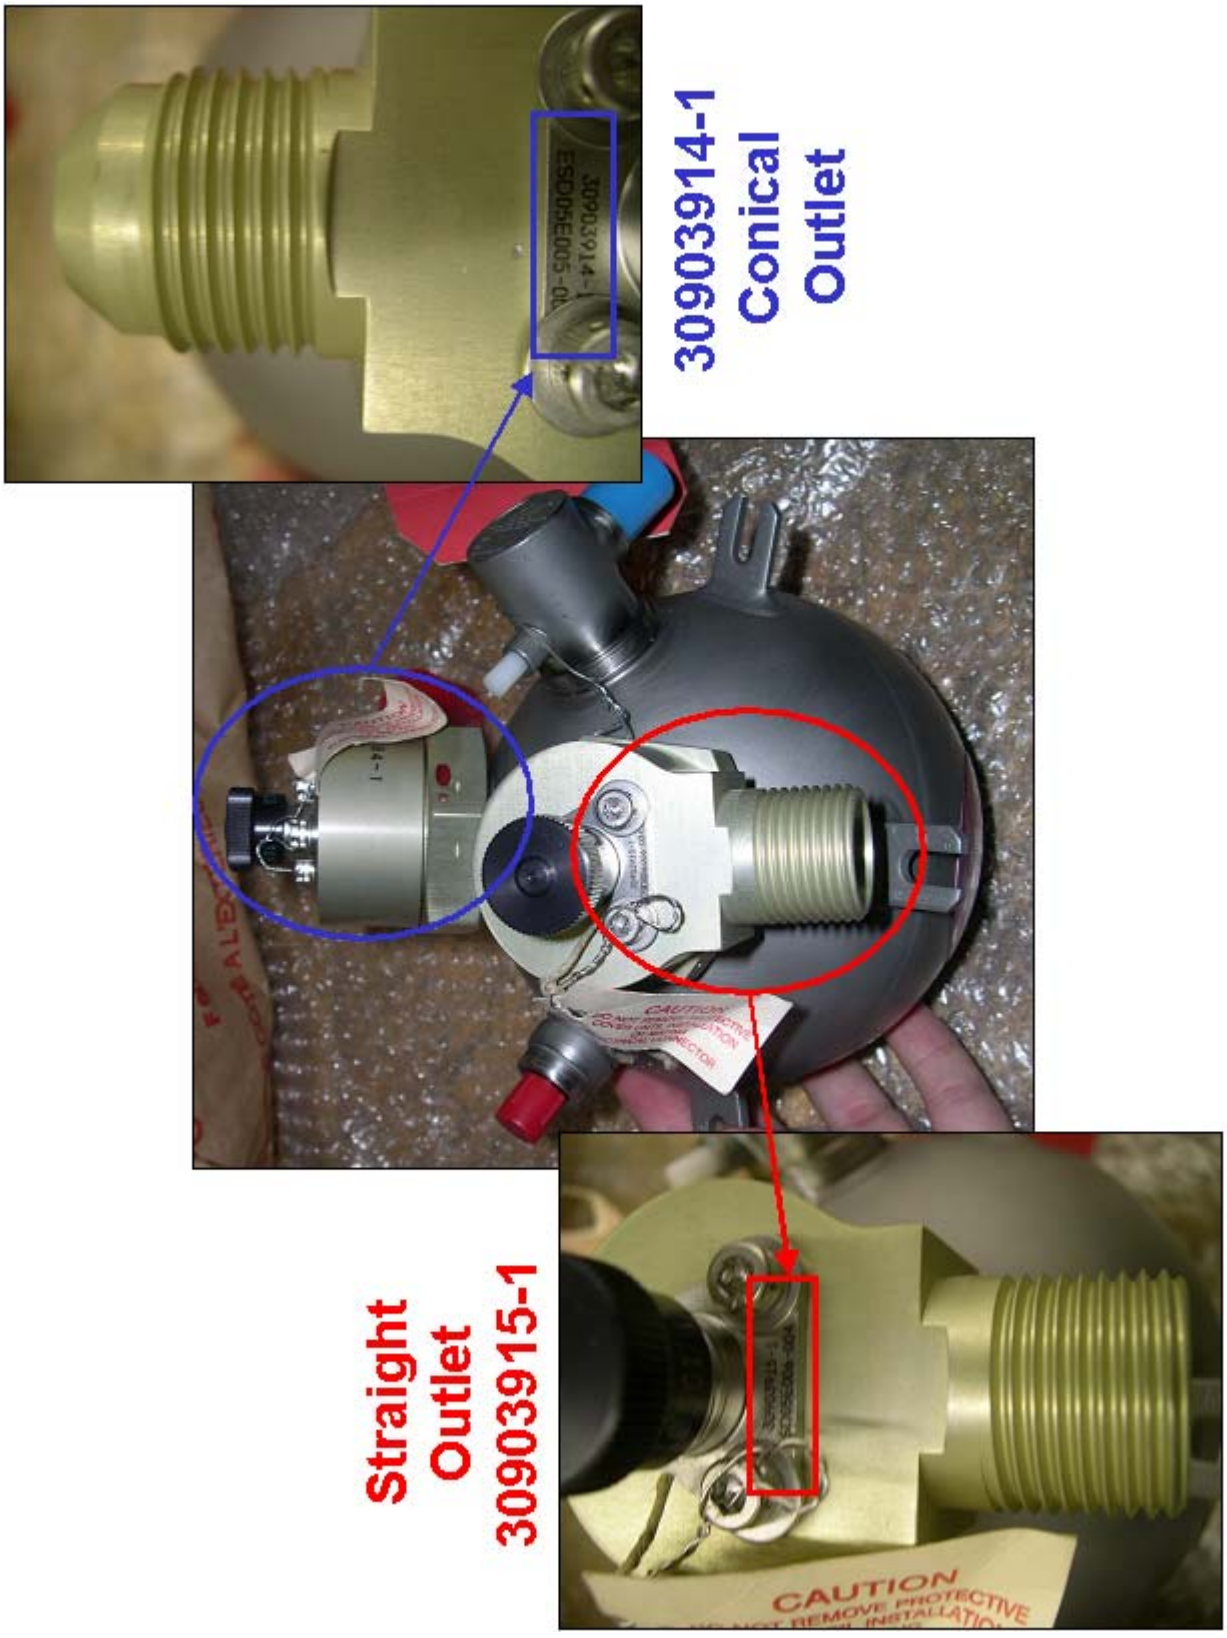
Figure 3

REASON: some bottles have been found with electrical receptacles installed on wrong outlet ends.

5. With reference to figure 3, make sure that:

a. Receptacle P/N 30903914-1 is installed on outlet end P/N MS33514G12.

Outlet end P/N MS33514G12 is the most distant from the central mounting lug of the bottle assy.

b. Receptacle P/N 30903915-1 is installed on outlet end P/N AS4395G12.

Outlet end P/N AS4395G12 is the closest to the central mounting lug of the bottle assy.

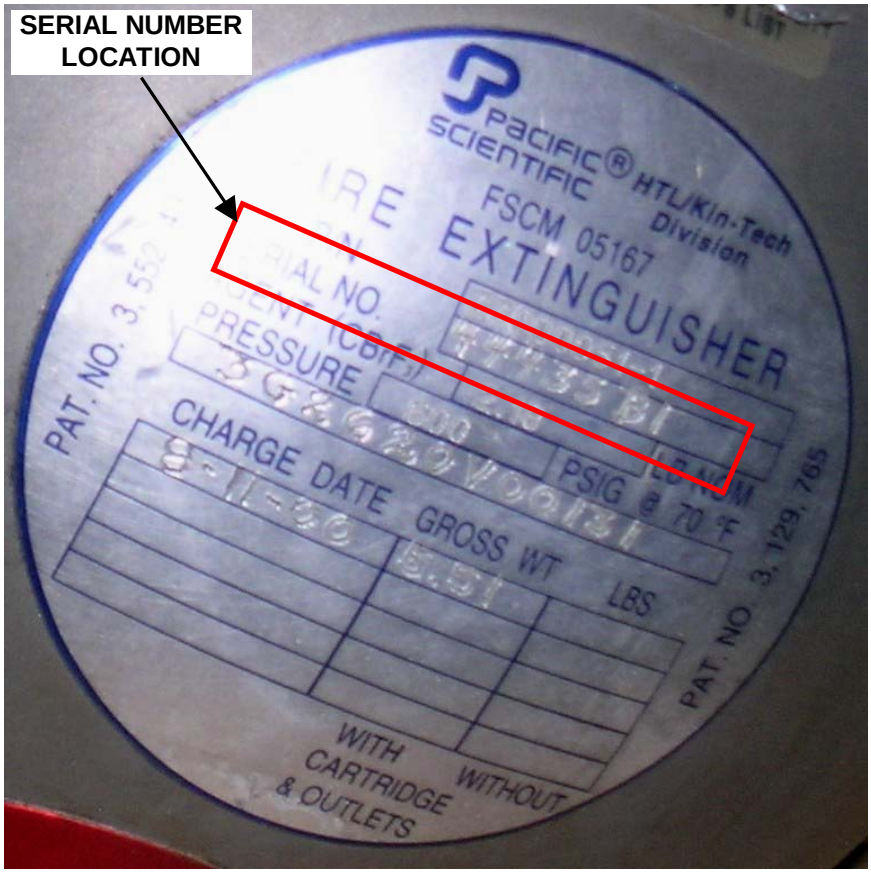
Figure 4

Bottles suspected to have the aforementioned defect are identified with S/N less than 56822B1 (bottle S/N coding is as XXXXXB1 and is located on the bottle placard shown in figure 4).
